SERVICE BULLETIN

No. 400-2-04

Subject: EA 400: Main hydraulic retraction actuator of the nose landing gear

Affected Aircraft: EA 400, S/N 03 up to S/N 026 & S/N 028

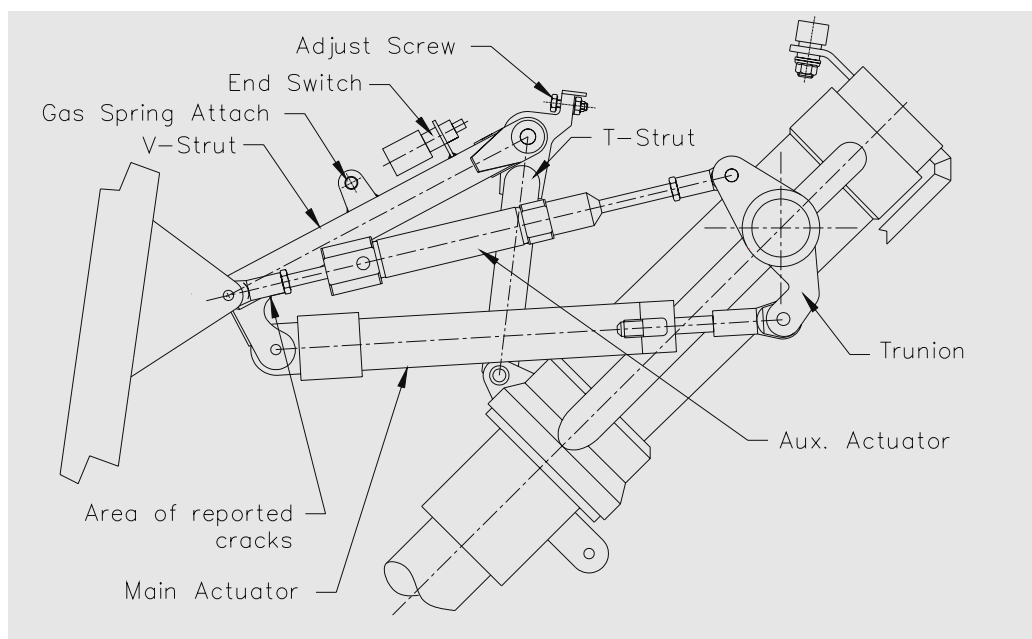
Purpose: Cracks have been reported at the V-strut of the nose landing gear radius strut, where the retraction actuator is connected to. It is suspected that the actuator displacement did not match the angular travel of the attachment bracket at the V-strut.

Visual check bracket at V-strut of the nose landing gear radius strut (where the main hydraulic actuator connects) for cracks, especially the root area of bracket, ref. to fig. 1.

Fig. 1: Overview NLG retraction devices

If cracks are suspected, a further detailed inspection is necessary. Disconnect both retraction actuators as well as the gas spring from the V-strut (refer to the provisions of Maintenance Manual Chapter 32-30-24 and 32-30-25) for that purpose. Disassemble the V-strut, remove paint at suspected area and perform a dye-check.

If no structural cracks are found, replace surface treatment in accordance with chapter 51-70-07 of Maintenance Manual EA-400 and reinstall strut, connect retraction actuators and gas springs.

If structural cracks are found, replace or repair V-strut (refer Maintenance Manual Chapter 51-70-05 & Chapter 51-70-07) and continue with provisions of Part II.3

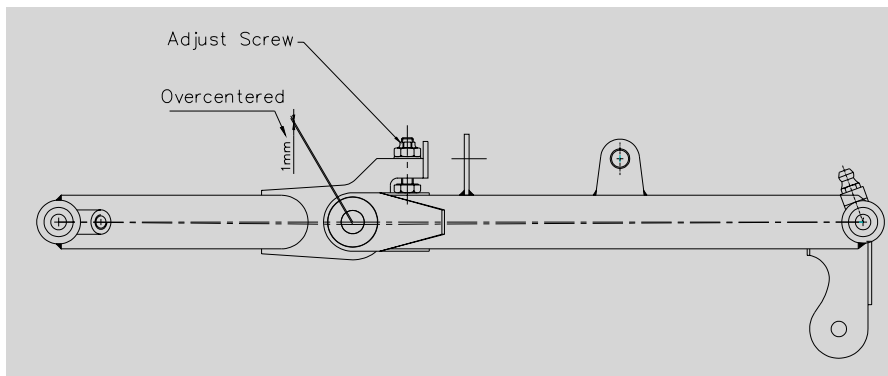
1. Aircraft is jacked up in the shop, landing gear extended, hydraulic pressure off (refer MM Chap. 32-30-24 above Step 2)
2. Disconnect both retraction actuators as well as the gas springs from the V-strut (refer to the provisions of Maintenance Manual Chapter 32-30-24 and 32-30-25) for that purpose. Remove end switch for extended position. Disassemble radius strut (V-strut and T-strut)
3. Check overcenter adjust of radius strut. If deviate from 1mm (see fig. 2&3) adjust by screw.

Fig. 2: Radius strut adjustment

26. Check overcenter adjustment: when landing gear is extended, there must be no gap between adjust screw of the radius strut and its related overcentering stop. Check by a sheet of paper.

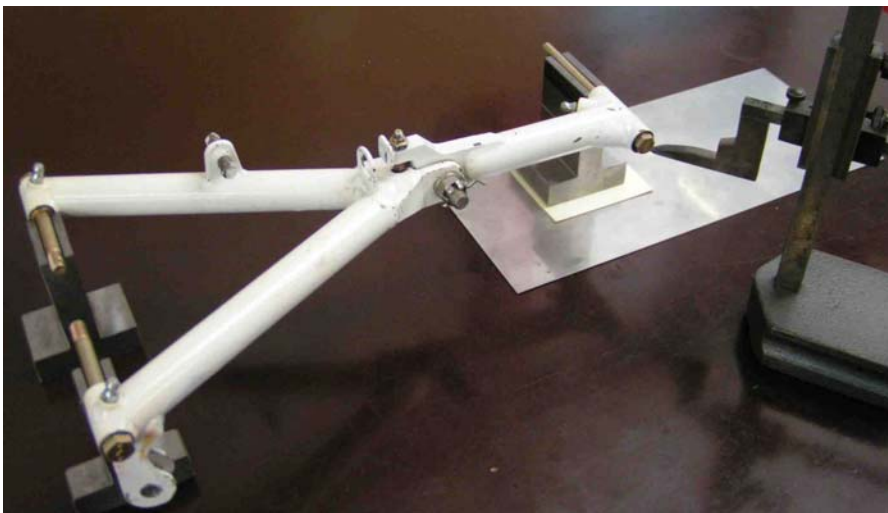
Fig. 3: Testing of radius strut adjusting (for example)

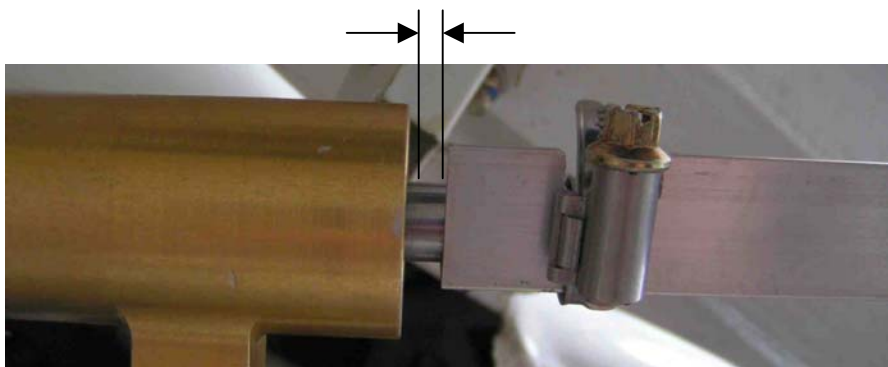
4. Reinstall radius strut and both hydraulic actuators. Reinstall end switch; verify the switch is activated if the radius strut has overcentered (check acoustically or by observing the green indicator light).
5. Install marking device (metallic block or angle, fixed by means of a clamp), at piston rod of main hydraulic actuator, similar to fig. 4., fixed without gap between cylinder housing and marking device.

Fig. 4: Marking device

6. Disengage connection between main hydraulic actuator and trunion.
7. **Caution:** Make sure that the landing gear control handle is still in the “down” position. Activate hydraulic pressure, nose gear main hydraulic actuator piston rod will move to the max. position.
8. Measure the additional travel of the piston rod (gap X between cylinder housing and marking). This is the needed length for the spacer bushing.
9. Remove marking device. Deactivate hydraulic pressure by loosening the hydraulic line connections. Remove main hydraulic actuator. **Note:** Catch spilling hydraulic fluid with suitable vessel.
10. Shorten the delivered bushing in accordance to the drawing to the measured length X +/- 0.1 mm.
11. Note the relative position of the rod end vs. piston rod before you disassemble the actuator.

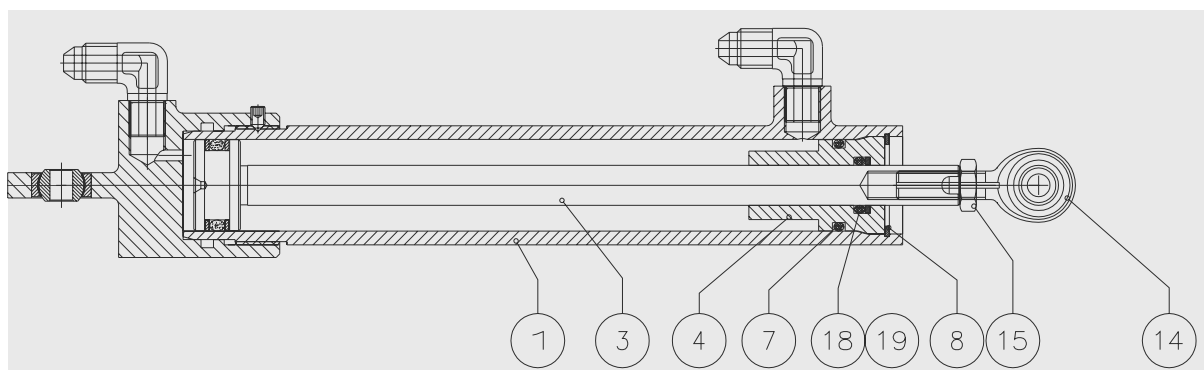
Fig. 5: Main hydraulic actuator

12. Disassemble the counter nut and rod end from piston rod (14&15).
13. Disassemble the Seegerring (8)
14. Pull the guidance (4) with the piston rod (3) out of the hydraulic actuator bore. The piston should remain within the actuator bore. **Note:** Catch spilling hydraulic fluid with suitable vessel.
15. Pull the guidance (4) from piston rod (3).
16. Push the spacer bushing onto the piston rod (3)

17. Replace the O-ring & packing of the guidance (7&18).
18. Reassemble the guidance to the cylinder bore.
19. Secure the guidance with the Seegerring to the cylinder.

20. Screw the rod end into the piston rod until the original measurement is reached. Secure with counter nut.
21. Reinstall actuator, connect to V-strut bracket.

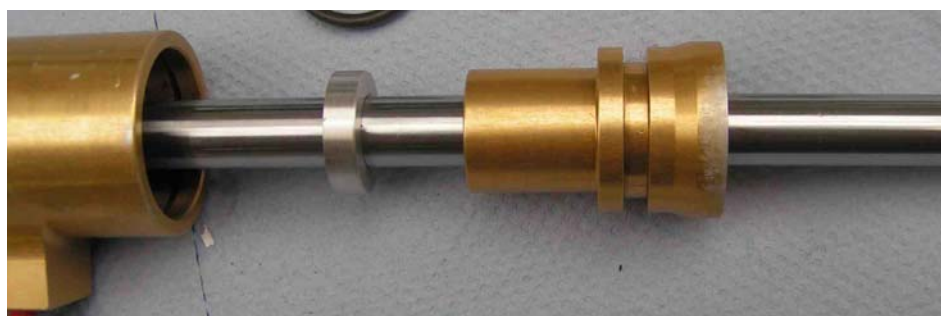
Spacer bushing installation in the main hydraulic actuator of NLG limiting the stroke of piston rod in extended gear position in accordance to the instructions.

Fig. 6: Installed spacer bushing

Spacer bushing P/N: 40553415 (oversize bushing)
O-Ring MS 28775-111,
O-Ring MS 28775-117
Packing MS 28774-111
Quantity: 1 each
